# COLLISION REPAIR INFORMATION

TITLE: FENDER BRACKET REPLACEMENT

SECTION: ELECTRICAL BULLETIN #184

MODELS: 2012- TOYOTA CAMRY/CAMRY HV and 2013- LEXUS ES350/ES300H

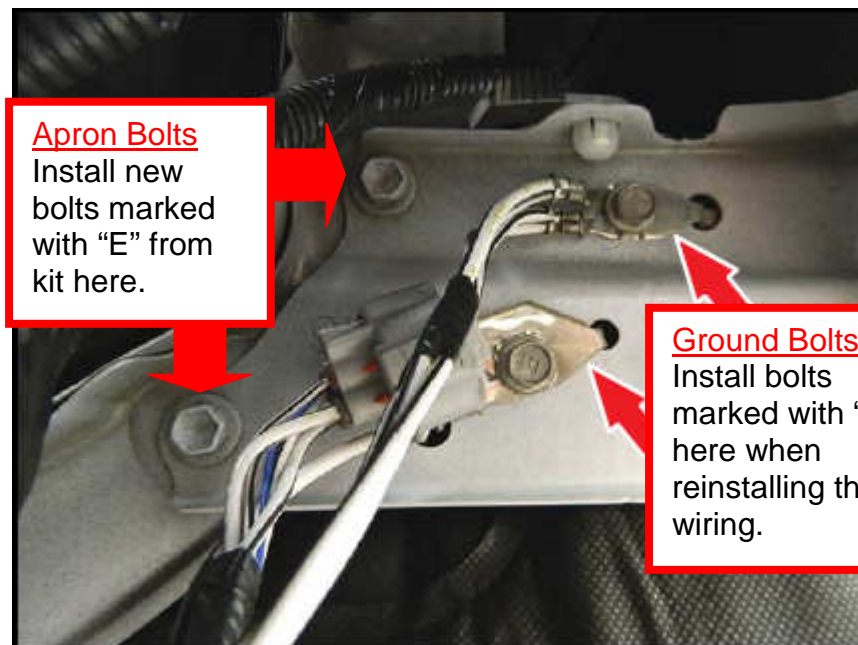
Model Year 2012- Camry/Camry HV and 2013- ES350/ES300H use the left front fender mounting bracket (Toyota PN 53804-33030 Lexus PN 53804-33040) as a ground location for an Integration Relay and the Engine Control Module. If this bracket is damaged and replaced, or repaired and reused, it is critical to follow the procedures and precautions provided below when removing or installing the bracket and ground wiring:

**Note:** Failure to follow these procedures and precautions to ensure a good ground circuit connection may cause damage to the electrical system.

- Before removing any ground wiring, disconnect the 12 volt negative battery terminal.

**At no time while the ground wiring is loose or bracket is removed should the battery be reconnected or engine started.**

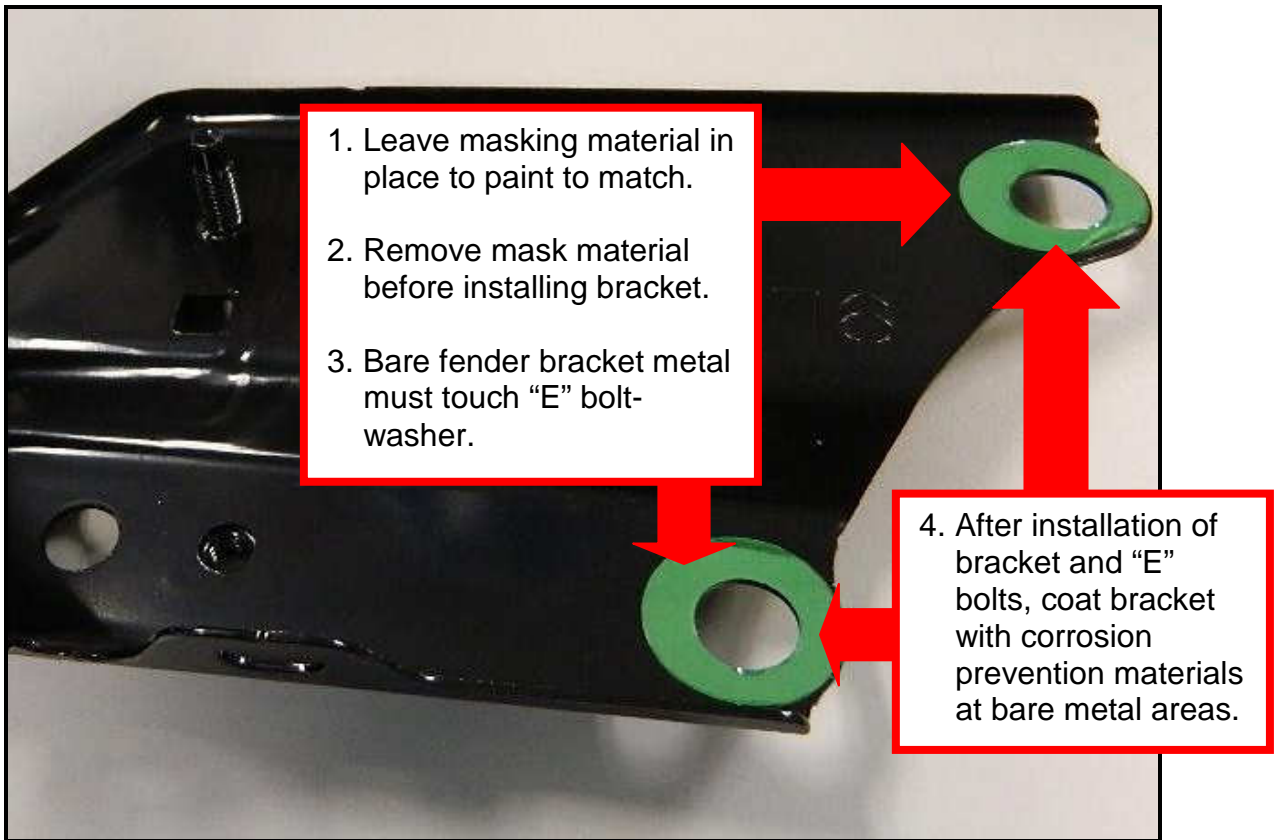
- Genuine OE replacement bracket kits are supplied with instructions, special attachment bolts and washers, as well as masking material at attachment bolt contact locations.

- Read and follow the new bracket installation instructions supplied in the kit.
- Do not remove the masking material on the new bracket before painting.

- Before installing the bracket remove masking material at apron attachment points.
- Use the new bolts supplied in the kit with the "E" marking on the bolt head. These bolts will cut thru paint and oxidation at the bolt threads to help ensure a good ground.

- Install bracket and ground wiring, and torque Ground bolts to 6.9-9.8 N\*m ( 5.1 – 7.2 ft\*lb) 70-100 kgf\*cm, and Apron bolts to 3.9 – 8.8 N\*m, (2.8 - 6.5 ft\*lb,) 40-90 kgf\*cm.

- Reattach negative battery terminal and check that ground wiring voltage drop is less than 0.2 volts.
- To prevent corrosion from developing at the bracket apron bolt hole area, neatly apply a heavy coat of a corrosion prevention material such as 3M™ Rust Fighter-I Part Number 08892 or equivalent around the area of the apron bolts.
