COLLISION REPAIR INFORMATION

TITLE: CLEAR COAT SOLVENT BLENDING
SECTION: REFINISH BULLETIN # 65
MODELS: ALL TOYOTA, LEXUS, and SCION
DATE: REVISED AUGUST 2013

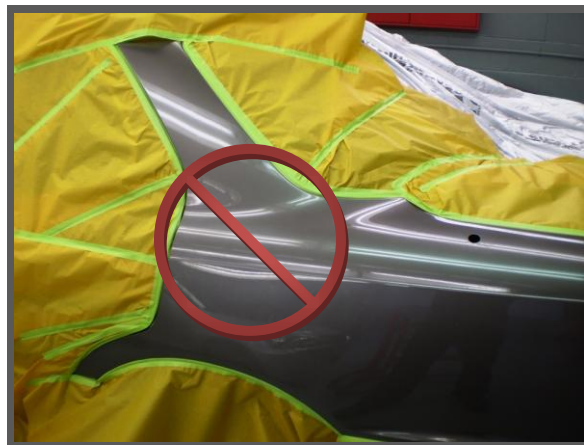
To achieve optimal paint film build for durability, paint manufacturers typically recommend 2.0 – 2.5 mils of clear coat film build. During solvent blending the clear coat film build is tapered from a recommended thickness to 0.0 mils. This lack of film build greatly reduces finish durability in the 'blend' area and leads to undesirable finish appearance issues such as:

- Hazing/Fading
- Visible blend lines
- Peeling/Delamination

Example Clear Coat Blend Preparation

Undesirable quality issues can negatively impact refinish durability, customer satisfaction, and the reputation of the repair facility performing clear coat blending. Therefore, Toyota recommends strongly against solvent blending clear coat.
